Manhole Inspection Summary

Manhole # S09AA2013MH

Location Address: **5862 PIMILICO RD** Cross Street: **ROCKWOOD AVE**

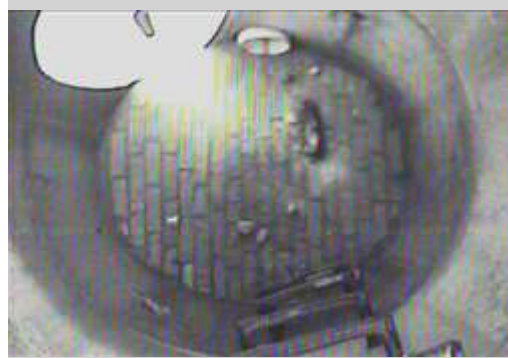
Top View

Barrel infiltration. Channel debris.

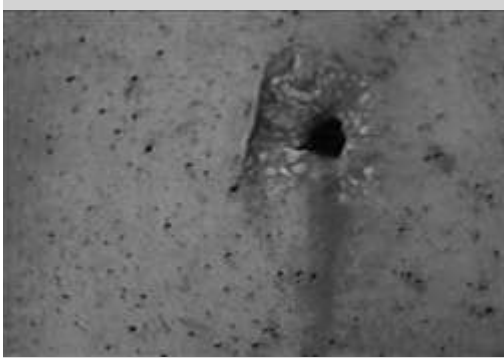
Weep hole in Barrel wall

Barrel infiltration.

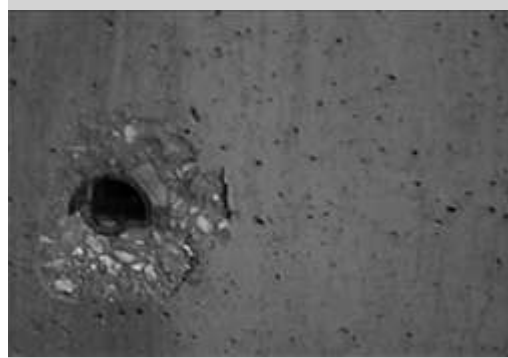
Weep hole in Barrel wall

Possible house connection.

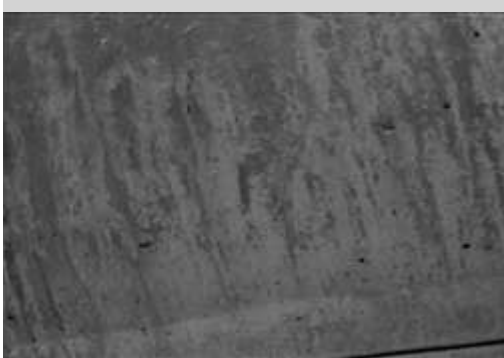
Defect

Corbel infiltration.

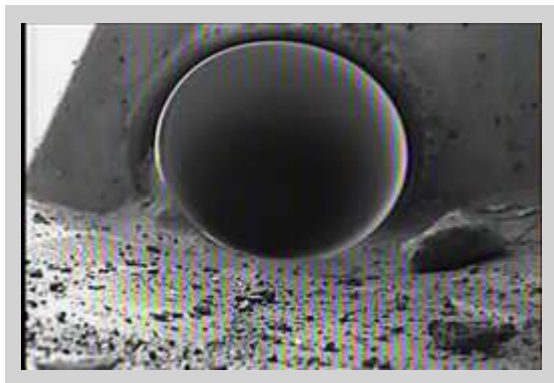
Pipe Out @ 12 O'Clock

Comments **The O12 pipe seal is not flush to the pipe.**
